**CR169 -Update of hydraulic tensioner tightening torque**  
**Panigale V4 (all model versions)**  
**Service Recall Campaign SRV-RCL-18-008**

Date: December 13, 2018  
 To: Dealer Principal, General Manager, Service Manager, North American Dealer Network  
 From: Richard Kenton, Technical Director  
 Matthew Feinstein, Regulatory Compliance Manager

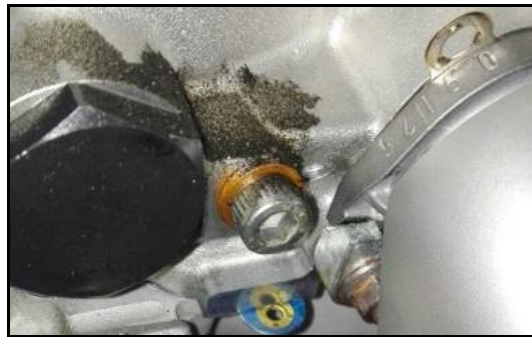
Ongoing quality tests performed on the product have shown a possible oil leak from one of the two hydraulic tensioners of the timing chains of the front and rear banks.

To prevent this issue we have increased the tightening torque of the two hydraulic chain tensioners. On all the above-mentioned vehicles it is necessary to update the tightening torque to **50 Nm ± 5%** (the previous tightening torque was 30 Nm ± 5%).

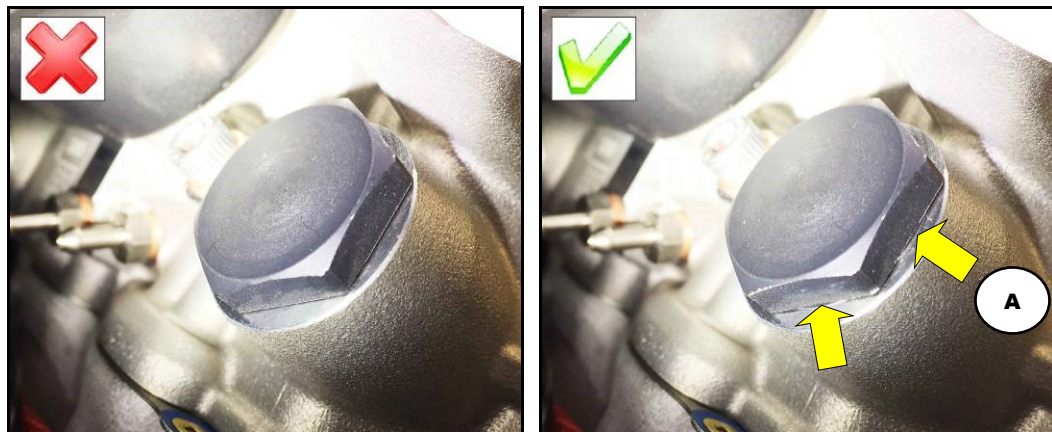
It is critical to perform the inspection without slackening the tensioner or removing the **washer (A)** as the washer is interference-fixed to the tensioner

- A. If **washer (A)** is not present, fill in a **YouTech** request attaching the detailed picture of the component and replace the hydraulic tensioner on a separate NORM warranty line repair
- B. If **washer (A)** is present, tighten the two hydraulic tensioners to the new tightening torque

The single washer is not available as spare part, therefore it is necessary to order and replace the complete tensioner.
